(INC. TREE SURVEY TO BS 5837:2012)

CLIENT - Statera Energy Limited

PROJECT - East Claydon

DOC. REF - P2892-AIA01 V1

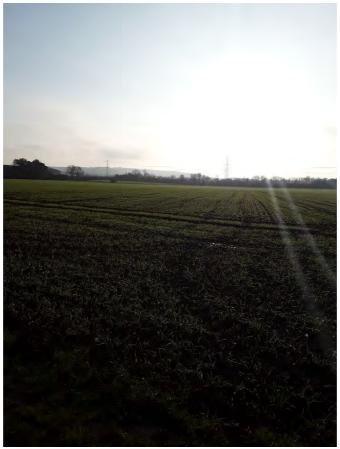
Figure 1 – Looking westwards at the site.

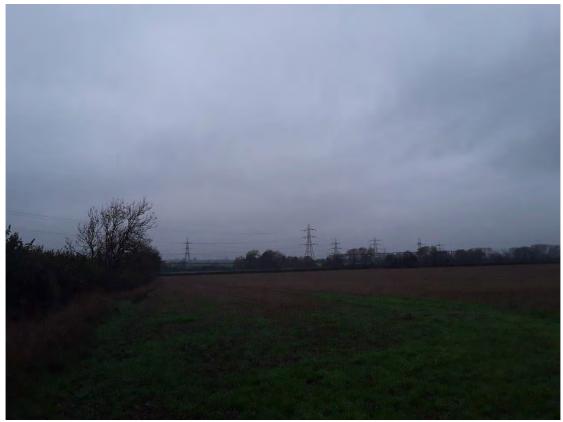
Figure 2 – Looking northwards towards the site.

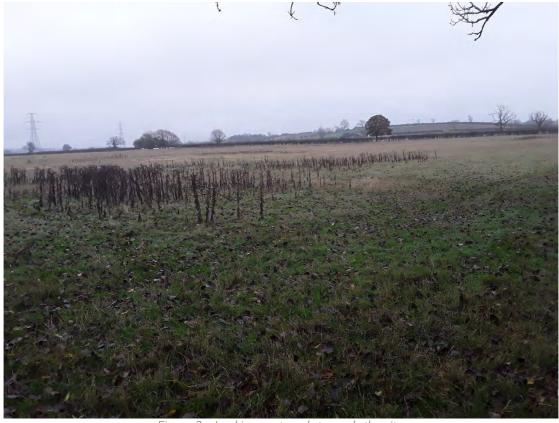
Figure 3 – Looking eastwards towards the site.

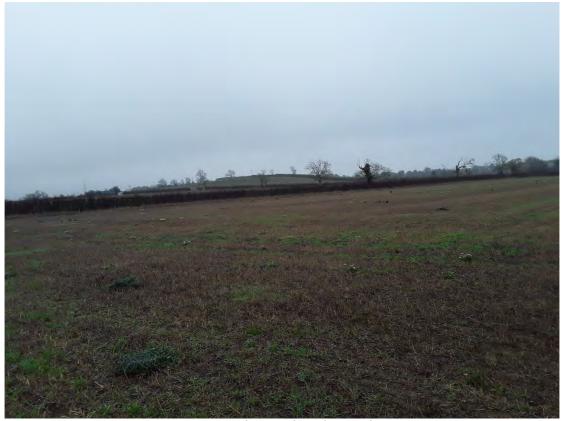
H5 requires a section measuring 35m in length removing from its easternmost end and H6 requires two sections measuring ~18m in total length removing to facilitate the construction of the proposed roadway.

Figure 4 – Looking northwards towards H5.

The removals from both H5 and H6 do not require offsetting through new plantings, however, with the proposed new woodland screening a proportion of species planted should be native and bear fruits for the wildlife, this will more than offset the proposed removals.

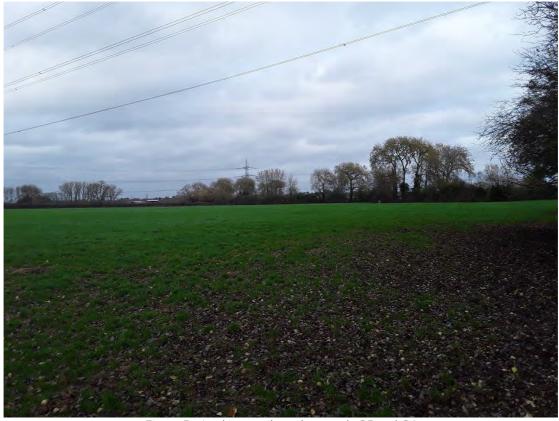
Figure 5 – Looking northwards towards G5 and G6.
